DEPARTMENT OF TRANSPORTATION

Contract #: 04-0120F4Cty: SF/ALA Rte: 80 PM: 13.2/13.9File #: 99.28**WELDING INSPECTION REPORT****Resident Engineer:**Siegenthaler, Peter**Address:** 333 Burma Road**City:** Oakland, CA 94607**Report No:** WIR-016568**Date Inspected:** 04-Sep-2010**Project Name:** SAS Superstructure**OSM Arrival Time:** 700**Prime Contractor:** American Bridge/Fluor Enterprises, a JV**OSM Departure Time:** 1900**Contractor:** Zhenhua Port Machinery Company, Ltd (ZPMC)**Location:** Shanghai, China

Orthotropic Box Girder (OBG) at Trial Assembly Areas

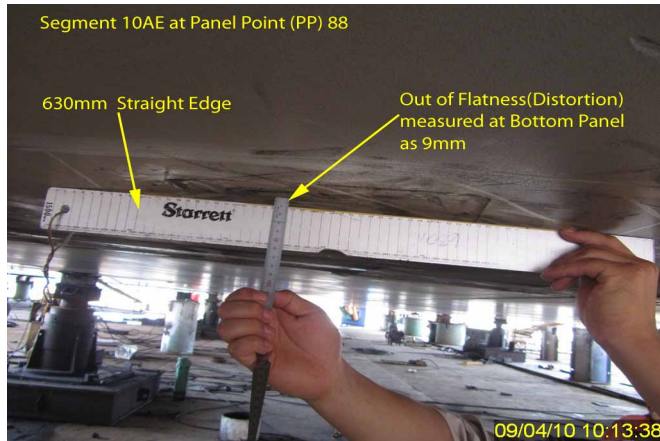
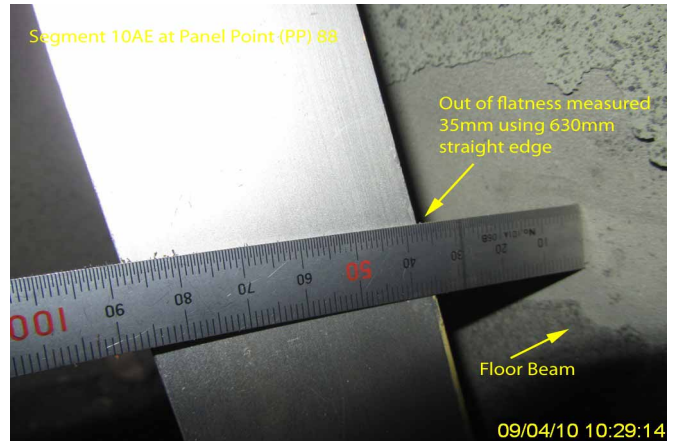
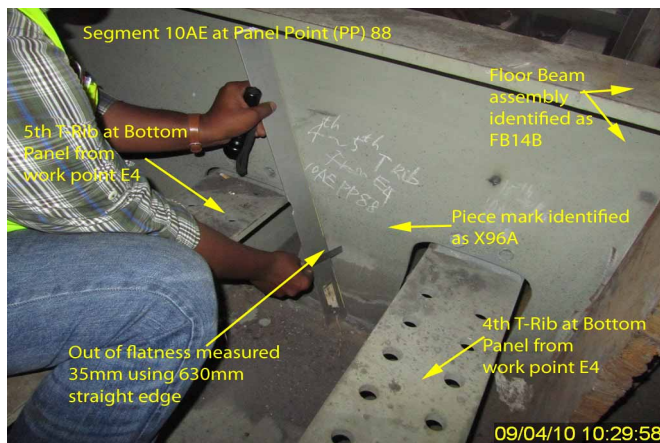
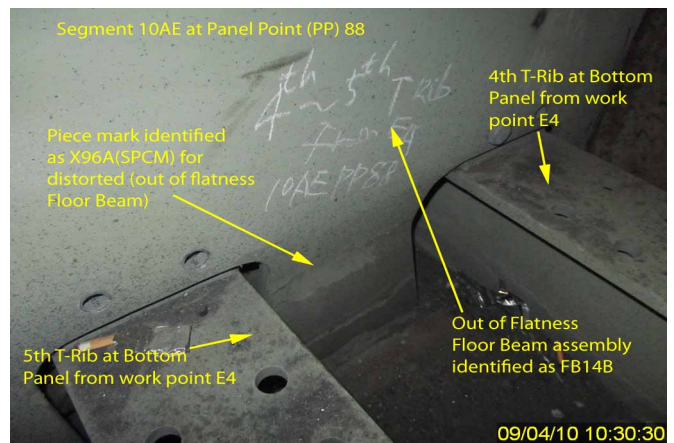
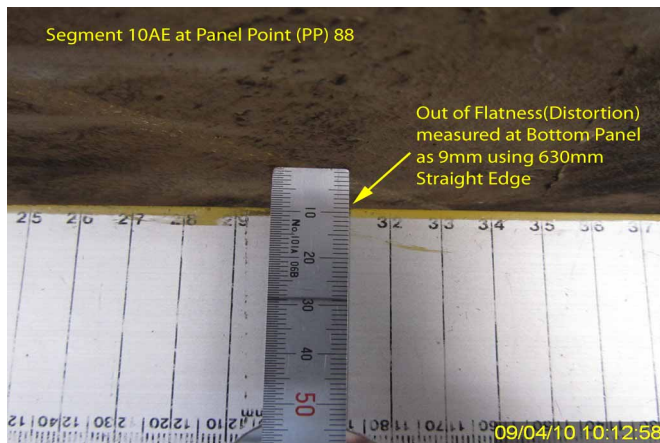
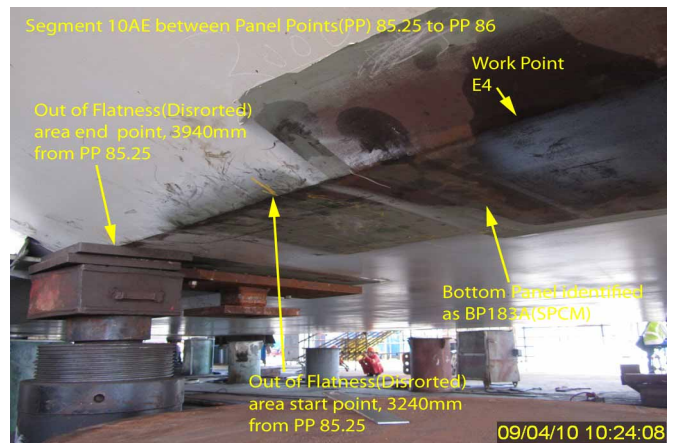
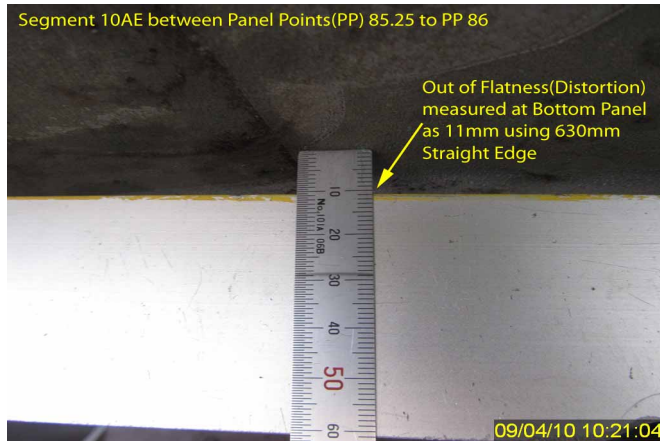
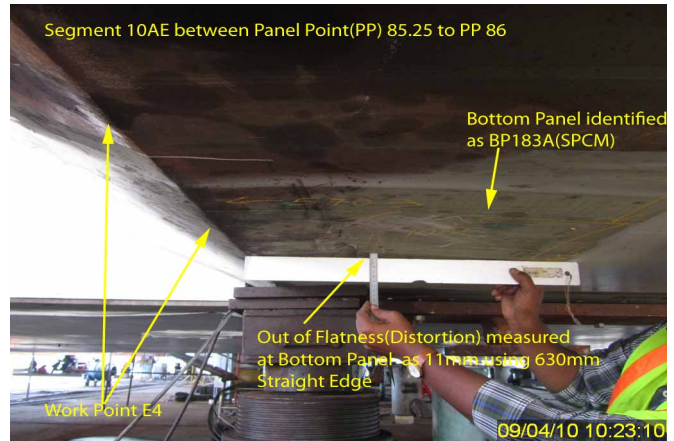
This Quality Assurance (QA) Inspector wrote an Incident Report for out of flatness issue which was visually observed at Bottom Panel for Segment 10AE at Panel Point (PP) 88 and between PP 85.25 to PP 86 at E4 location. Please reference the Incident Report # 04-0120F4_TL-15_B278_09-04-10_10AE_Out_of_Flatness_Bottom Panel_PP88 and PP85.25 to PP 86 dated September 04, 2010 for further detail.
